MERRIMACK RIVER BASIN  
EPSOM, NEW HAMPSHIRE

NORTHWOOD LAKE DAM  
NH 00285

PHASE I INSPECTION REPORT  
NATIONAL DAM INSPECTION PROGRAM

OCTOBER 1978

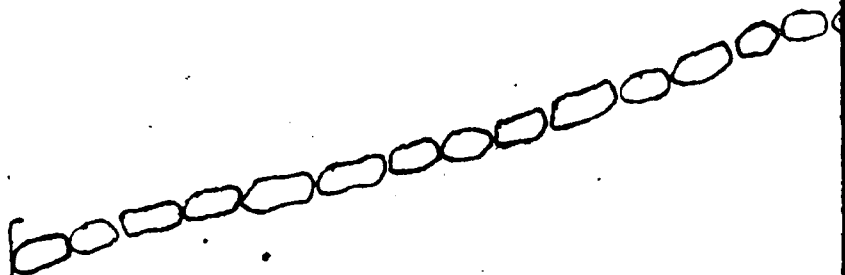
HARRIS-ECI ASSOCIATES  
 NORTHWOOD LAKE DAM DWG.  
 FIELD INSPECTION SKETCH 1

50' ± OF CURVE

EL. 53.4 TO 53.5
